FARMINGTON RIVER BASIN
TOLLAND, MASSACHUSETTS

LOST WILDERNESS LAKE
NORTHERN DAM
MA 01059

PHASE I INSPECTION REPORT
NATIONAL DAM INSPECTION PROGRAM

DECEMBER 1979

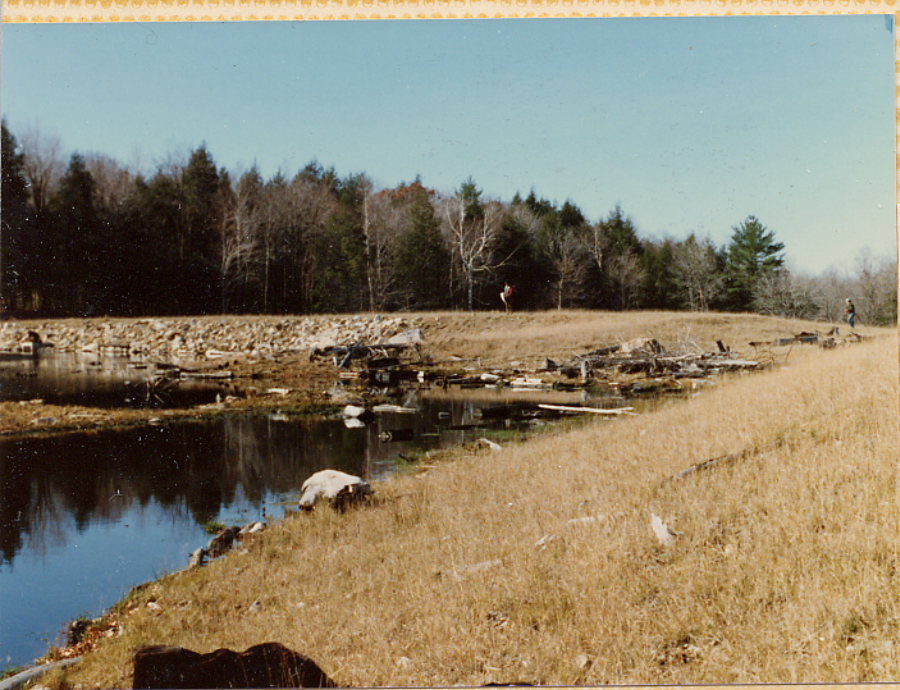
The upstream slope is protected by riprap and is in good condition. There is considerable debris on the upstream slope near the entrance to the emergency spillway. An inspection of the upstream slope showed no evidence of erosion or animal borrows along the slope.

The shore of the reservoir is generally gently sloping woodland. It appears stable and in good condition. However, there is considerable debris along the entrance to the emergency spillway.

Photo 1 - Dam over-view looking westerly from dike. Note debris at entrance to the emergency spillway.

Remedial measures to be undertaken by the Owner include: implementing a program of periodic maintenance; backfilling tire ruts, erosion, and low spots in the embankment and the dike; mowing embankment slopes and removing debris from the emergency spillway entrance.

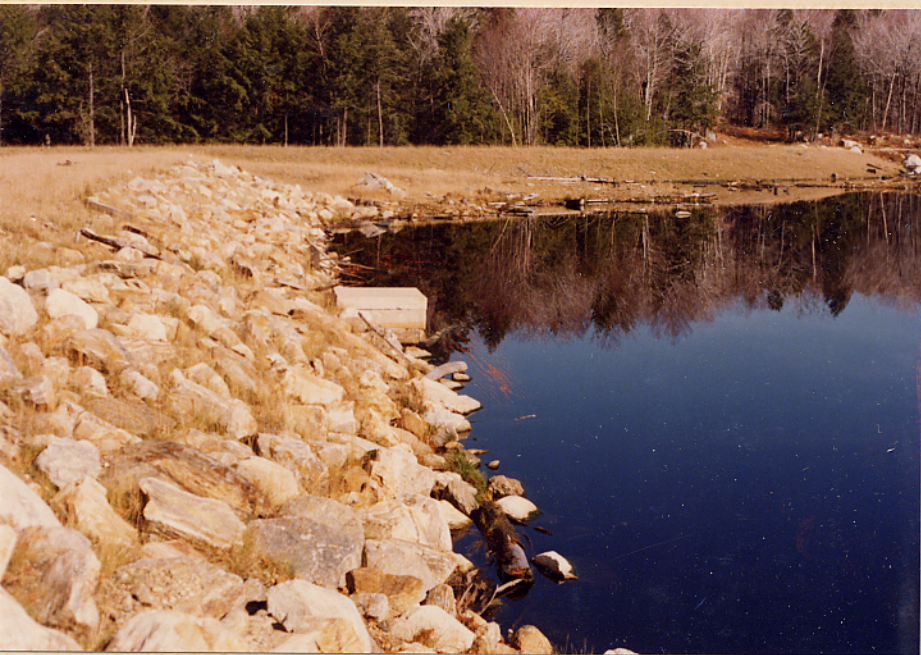
Photo 2 - Dike over-view looking northerly from left abutment of dam. Note drop inlet principal spillway structure.

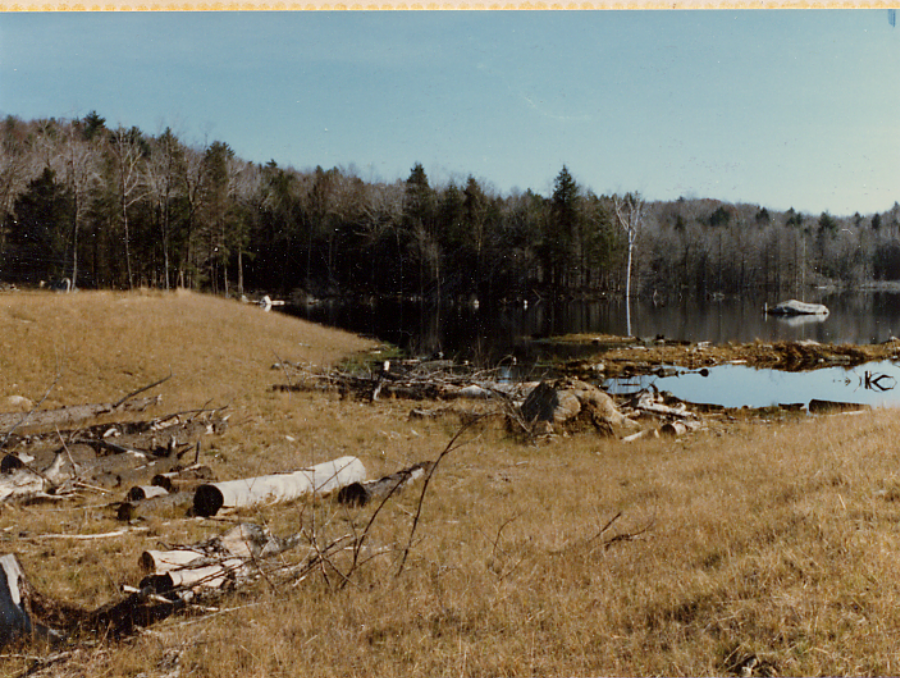
The emergency spillway is in fair condition. The entrance is partially blocked with considerable debris and the channel has a few rock outcrops that were not removed during construction. These outcrops decrease the area of the spillway and will tend to collect debris near the control section.

Photo 3 - Entrance to emergency spillway looking easterly from right side of embankment. Note debris and rock outcrop.

The rock outcrops in the emergency spillway channel should be removed to provide the design cross-section through the spillway. The source of the wet condition along the downstream toe of the dike should be investigated and remedial action taken if necessary.

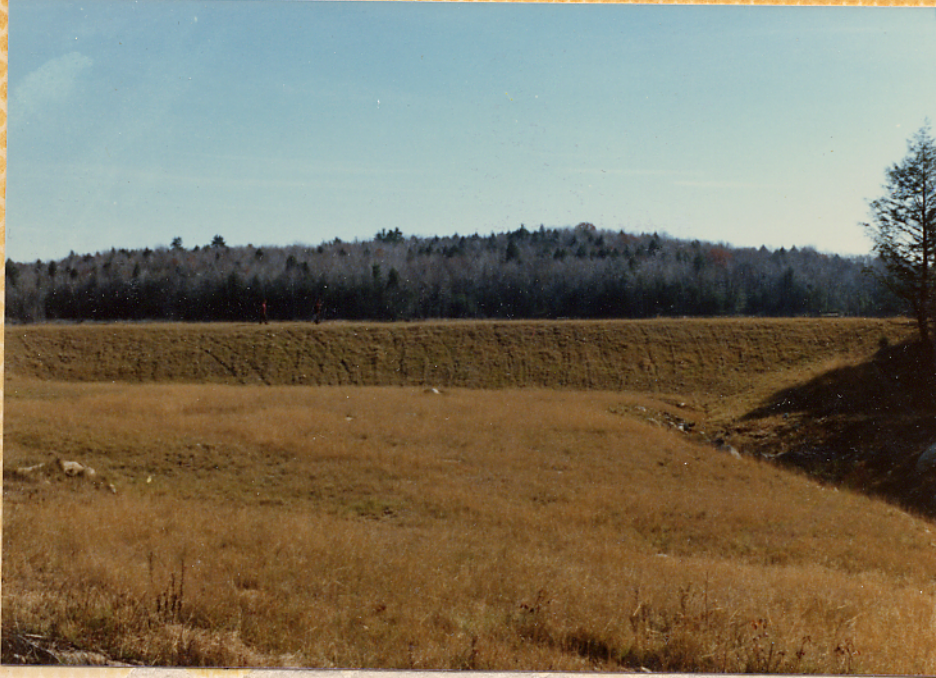
Photo 4 - Dam over-
view looking easterly
from downstream slope
of emergency spillway.
Note tracks on down-
stream face of embank-
ment.

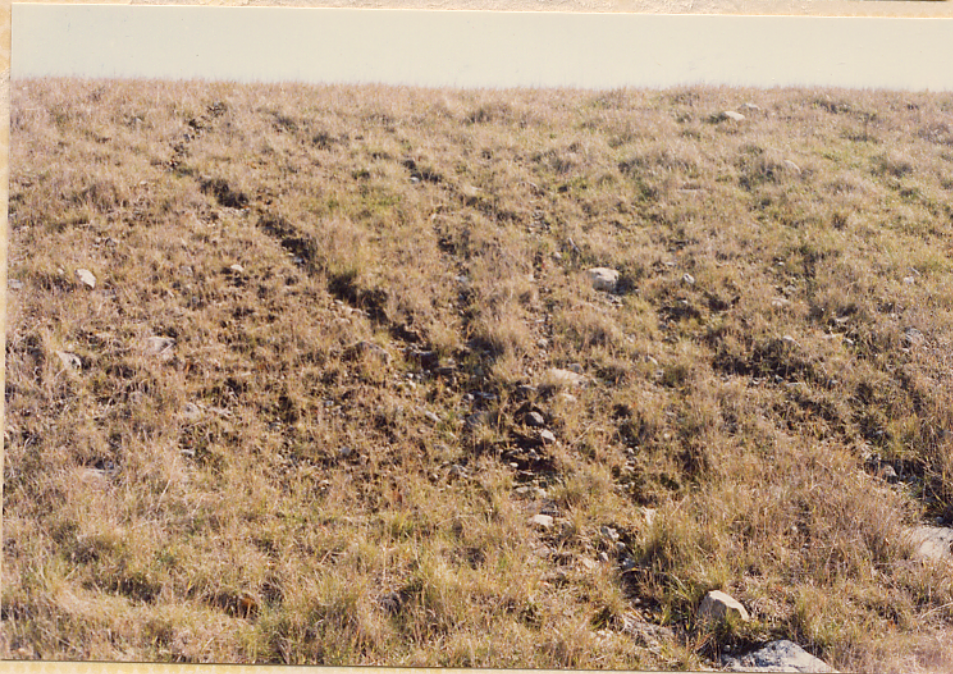
Photo 5 - Close-up
of tracks on downstream
face of embankment.
Note additional erosion

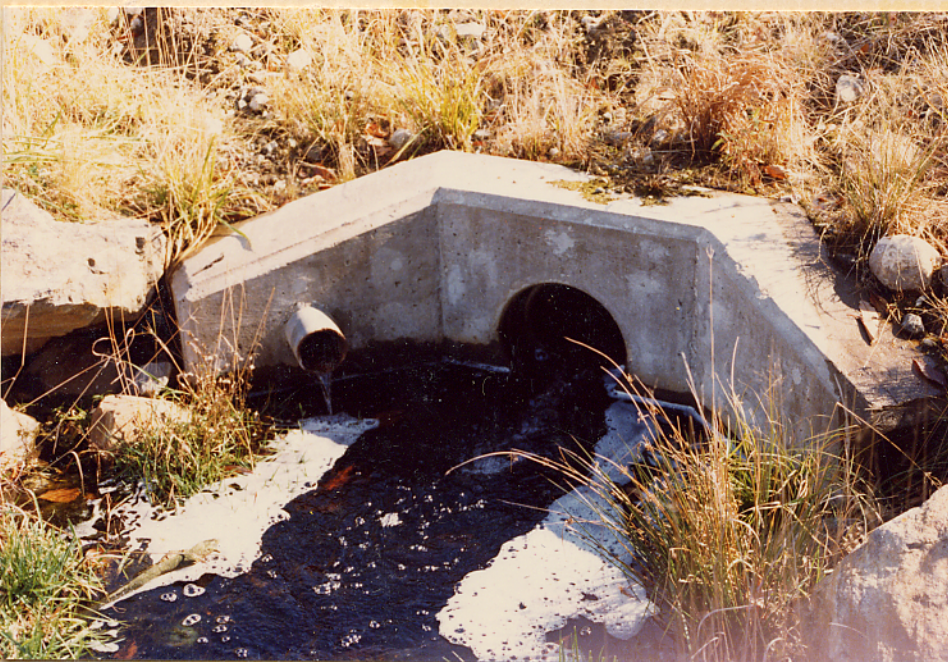
The downstream end of the outlet pipe is in good condition. There is no evidence of settlement or displacement of the conduit and no misalignment or cracking was evident on the inside of the pipe for those few sections that could be observed.

Photo 6 - Headwall for
10-inch principal
spillway pipe and toe
drain, looking easterly
from downstream
channel.

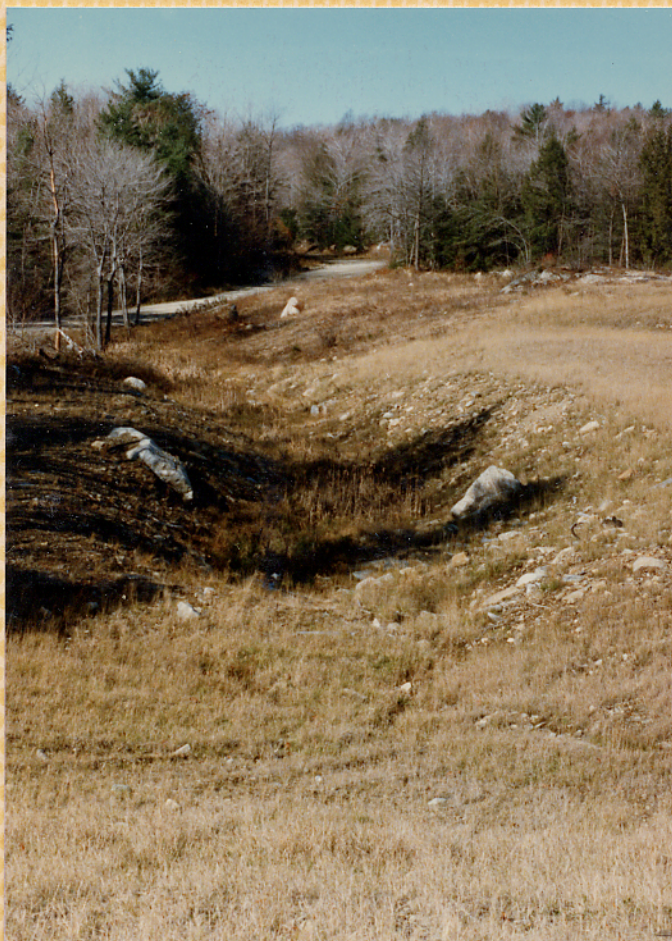
The downstream channel is a narrow channel passing through moderately sloping woodland. The channel appears stable and in good condition. The plunge pool is in good condition but is not completely protected by riprap.

Photo 7 - Overview of discharge channel and downstream conditions. Looking westerly from downstream slope of embankment.
